ESL-TR-91-13
VOL II

**EXPEDIENT REPAIR OF STRUCTURAL
FACILITIES (ERSF) - VOLUME II: ERSF
SYSTEM REQUIREMENTS AND USERS
GUIDE**

**APPLIED RESEARCH ASSOCIATES, INC.
P. O. BOX 40128
TYNDALL AFB FL 32403**

JULY 1991

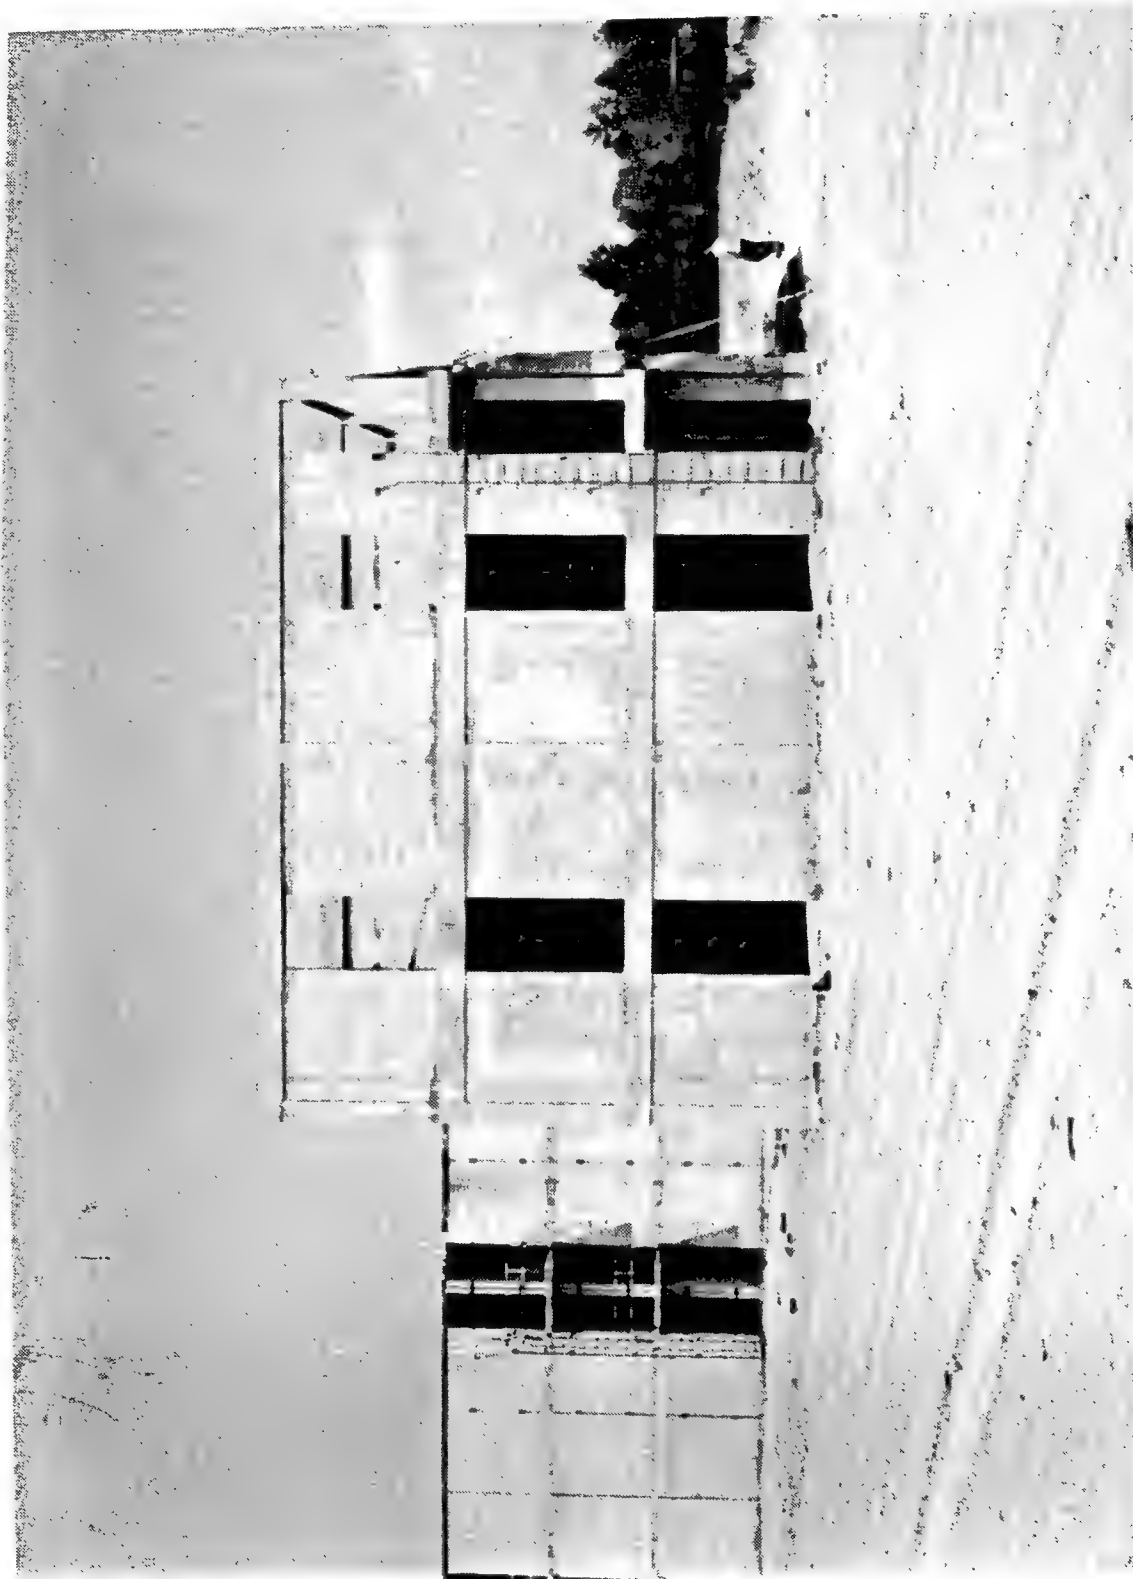
Figure 44. C 74 Structure Used for the Column Replacement Field Demonstration.

On 26 March 1990 at the Eglin AFB, AFESC/RDCS conducted a field evaluation/demonstration of the ERSF glulam column replacement system. The demonstration was done at the Eglin C-74 test range, using the reinforced concrete frame structure shown in Figure 44. This structure, including a 14-inch square reinforced concrete column, was severely damaged when used as a target for testing explosive munitions. The damaged column was replaced by a 10.75-inch square glulam column. The damaged column is shown in Figure 45. Engineering drawings of the column replacement process are shown in Figures 46 and 47. The column replacement process was accomplished twice, by a team of five Air Force Reserve personnel brought in for the demonstration by Mr. Bob McMahon of AFESC/DEO. The team was from the Indiana Air National Guard's

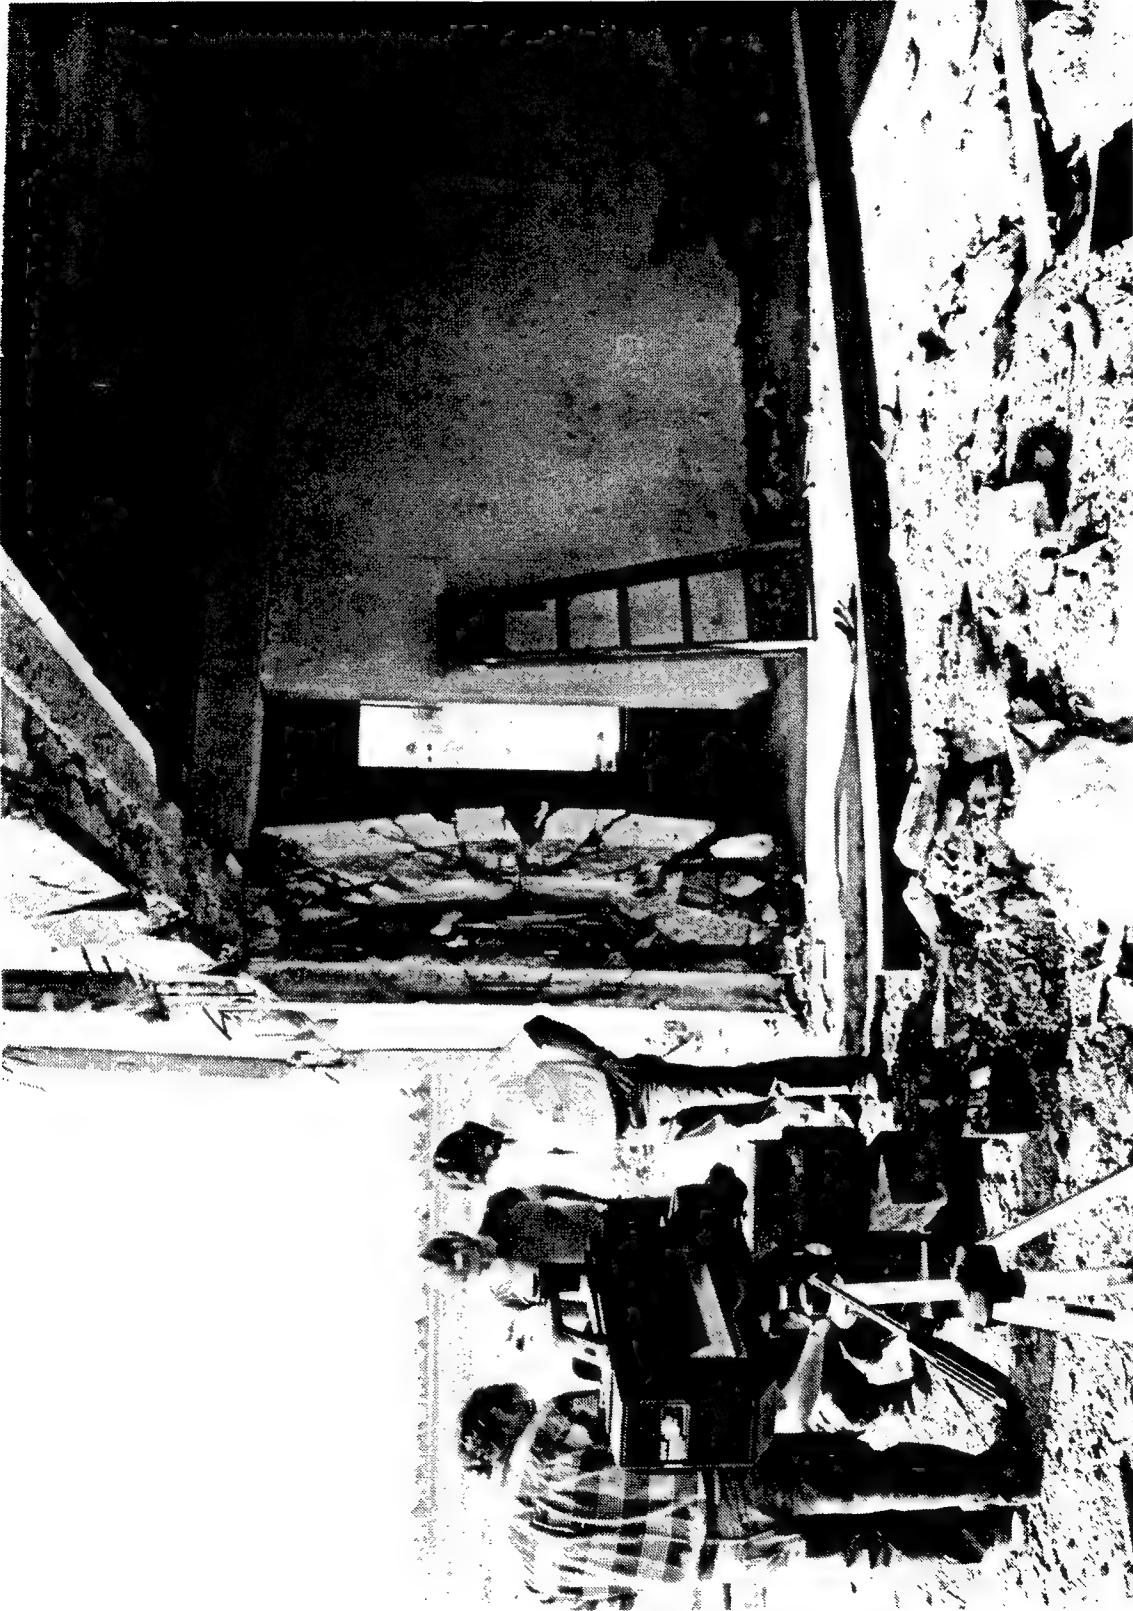
Figure 45. C 74 Structure's Destroyed Column Used for the Column Replacement Field Demonstration.

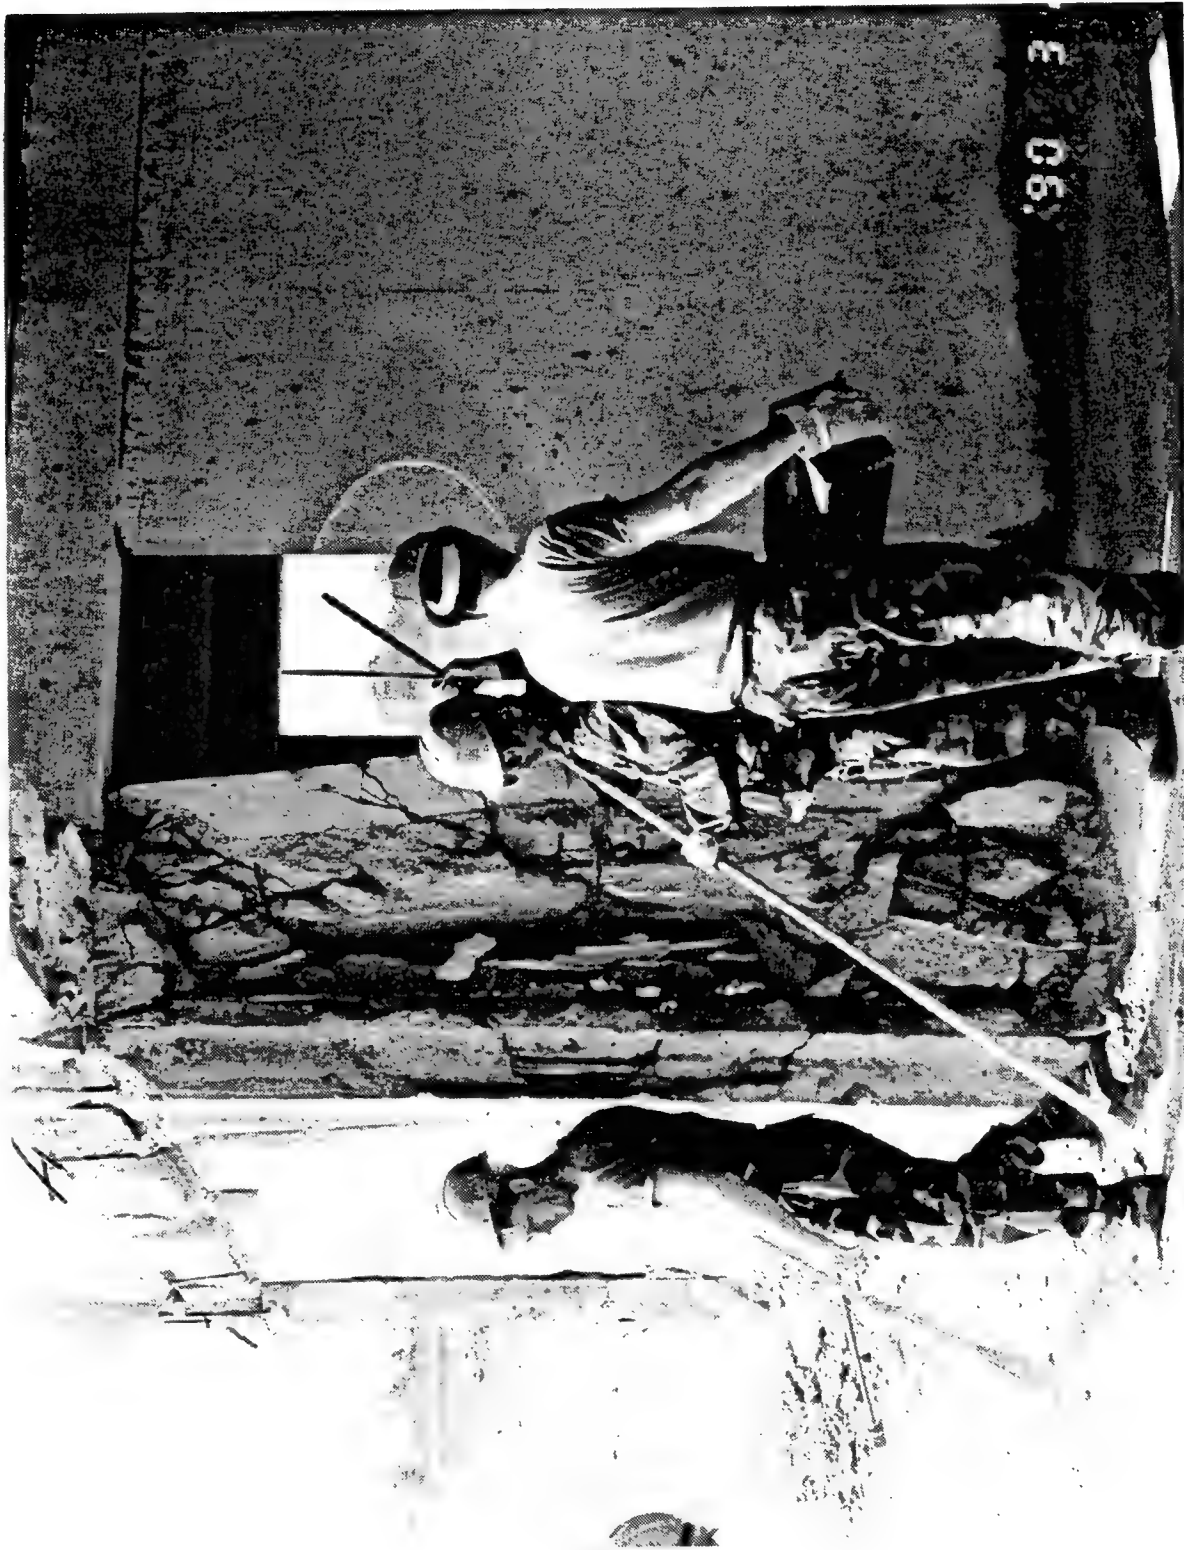
Figure 49. Height Measurement Next to Destroyed Column.

Views of the column replacement process are shown in Figures 48 through 55. Debris was cleared from around the column (Figure 48). A height measurement was taken next to the damaged column, to find the required replacement column length (Figure 49). The glulam column was then trimmed to the correct length using a chainsaw (Figure 50), while a shoring jack was placed next to the damaged column and extended by hand to refusal (Figure 51). The length of the glulam column was trimmed to leave a 1/2-inch gap between the top of the column and the bottom of the roof beam. This allowed wooden wedges to be inserted between the column and the roof beam to firmly secure the column in place. The glulam column was then positioned next to the shoring jack (Figure 52), and the wedges inserted (Figure 53). Lateral bracing consisting of two-by-fours was attached to the glulam column with nails, and anchored to two-by-fours secured to the concrete floor of the structure with ramset studs (Figure 54). Finally, the shoring jack was removed (Figure 55) completing the column replacement process.

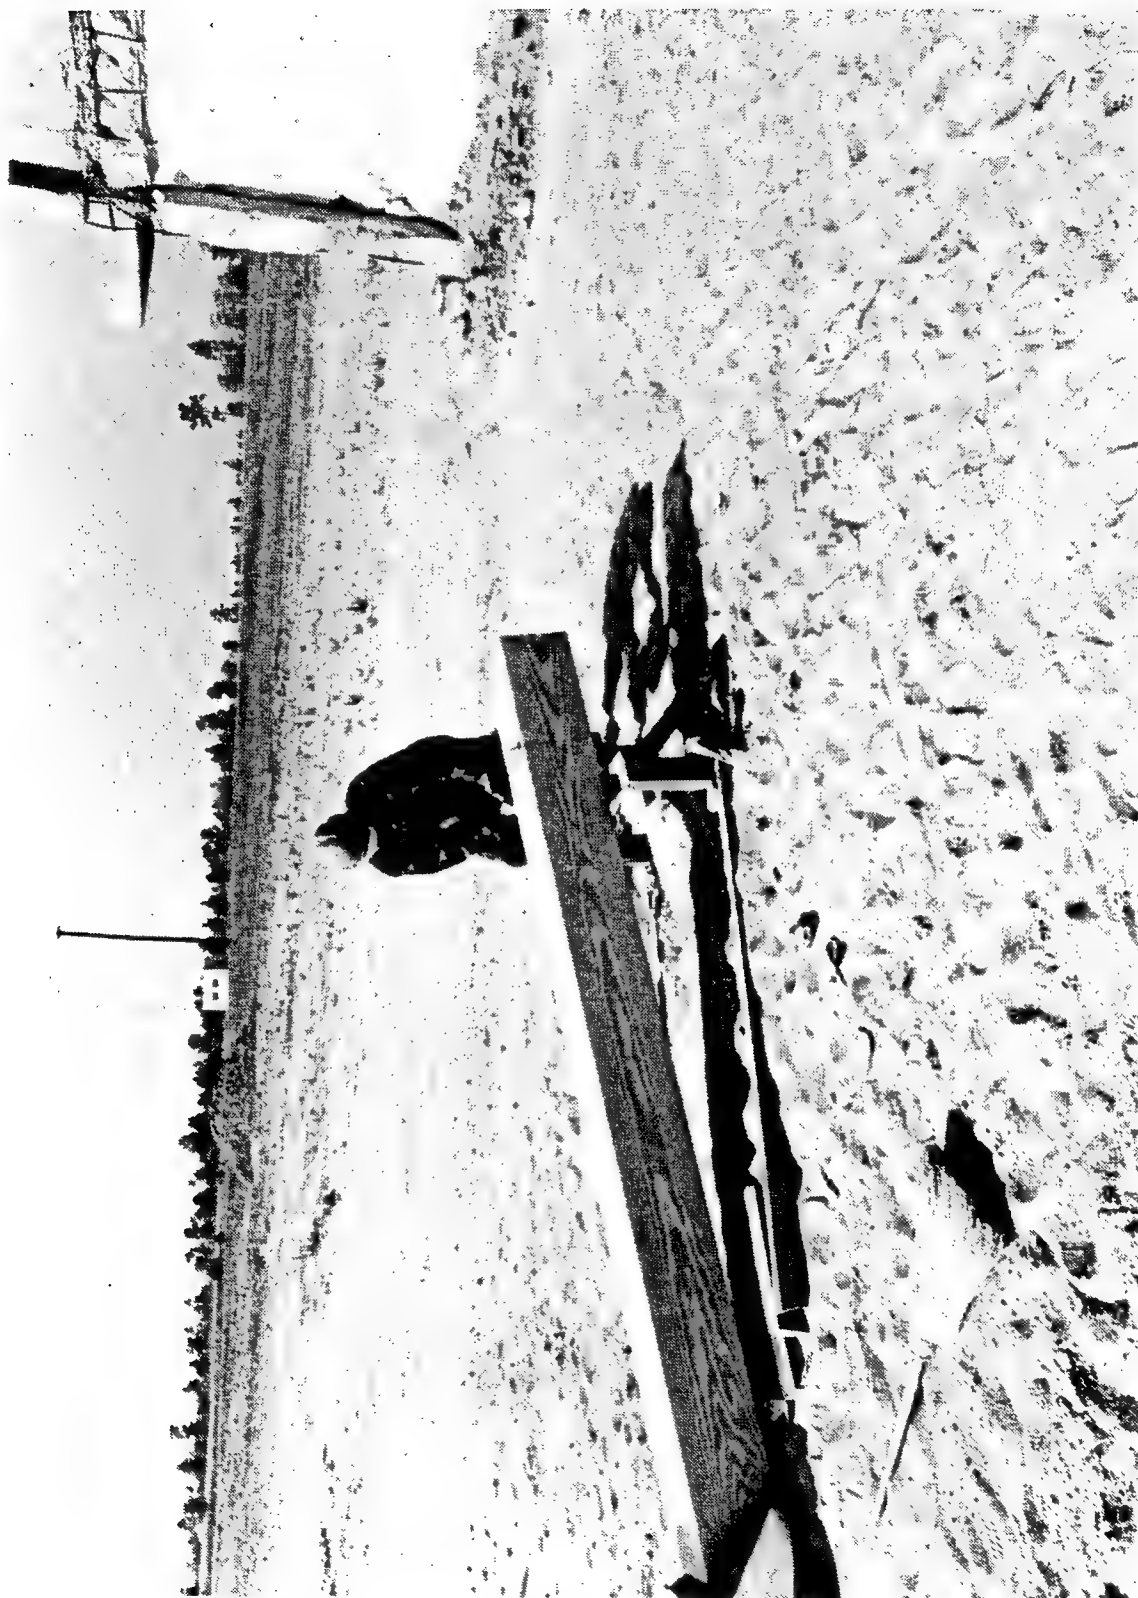
Figure 50. Trimming Glulam Timber Column to Correct Height.

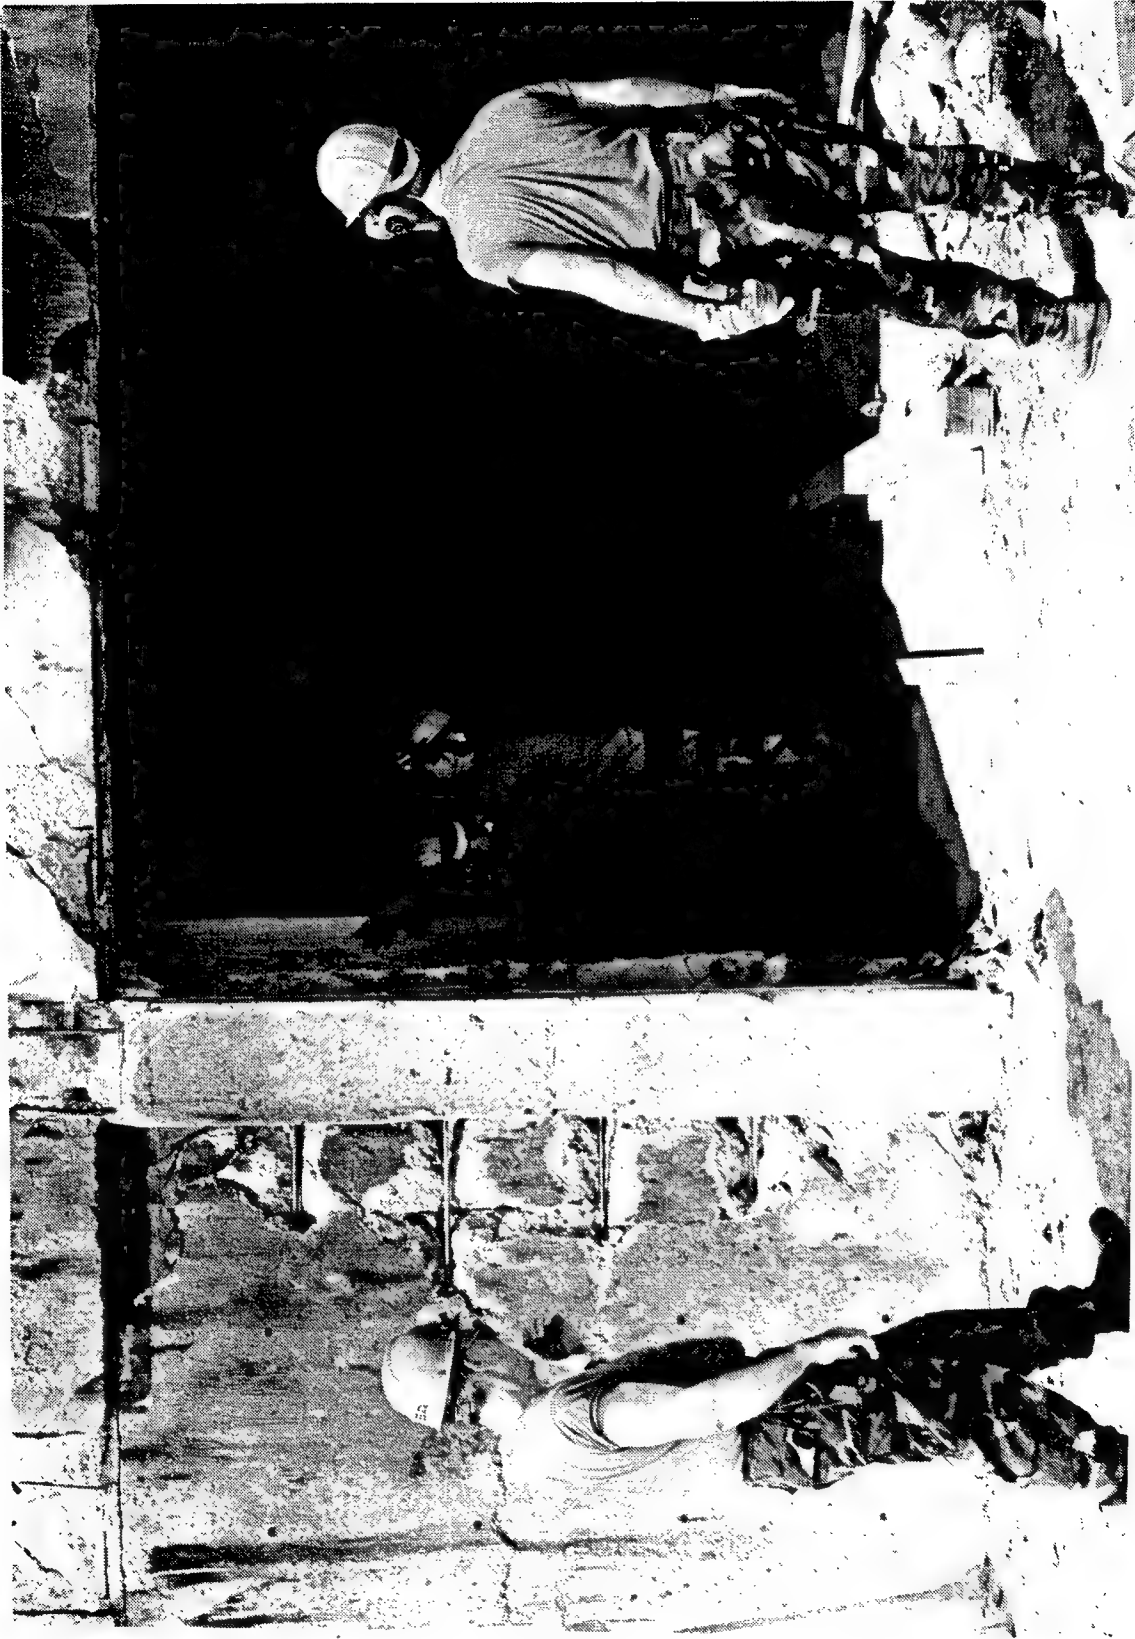
Figure 52. Placing Trimmed Glulam Timber Column Next to Shoring Jack.

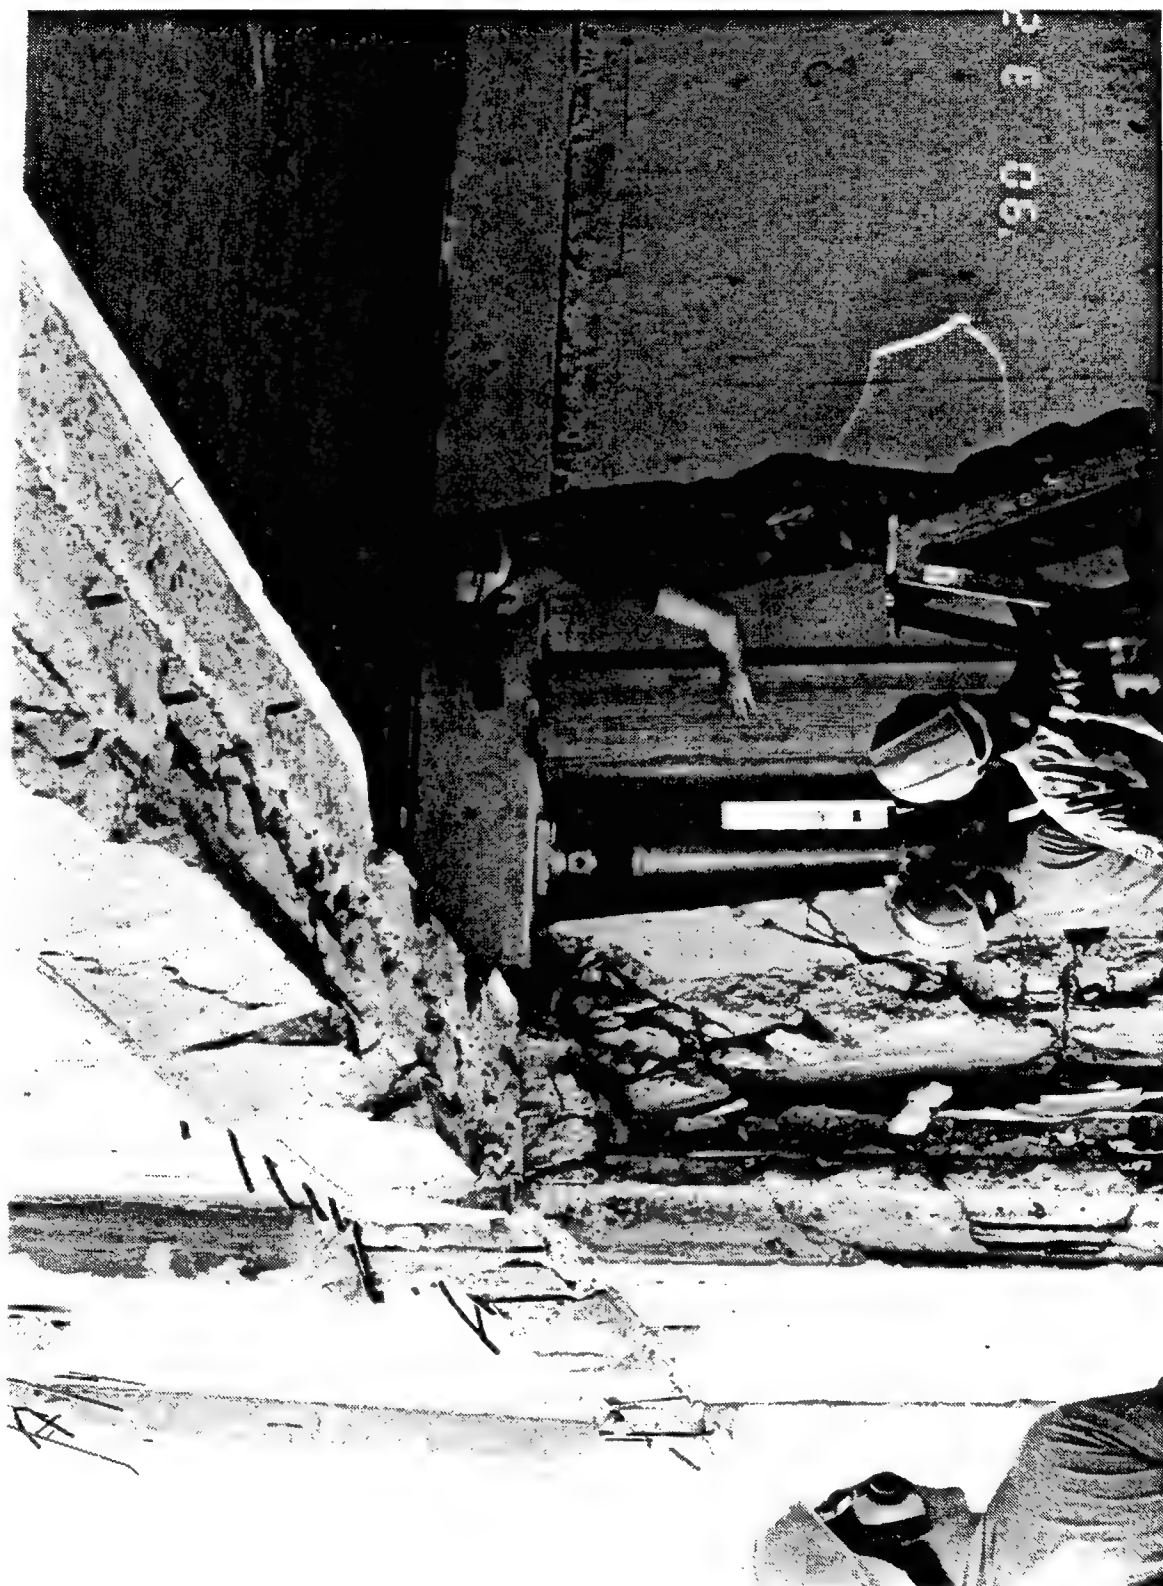
Figure 53. Inserting Wooden Wedges Between Replacement Column and Roof Beam.

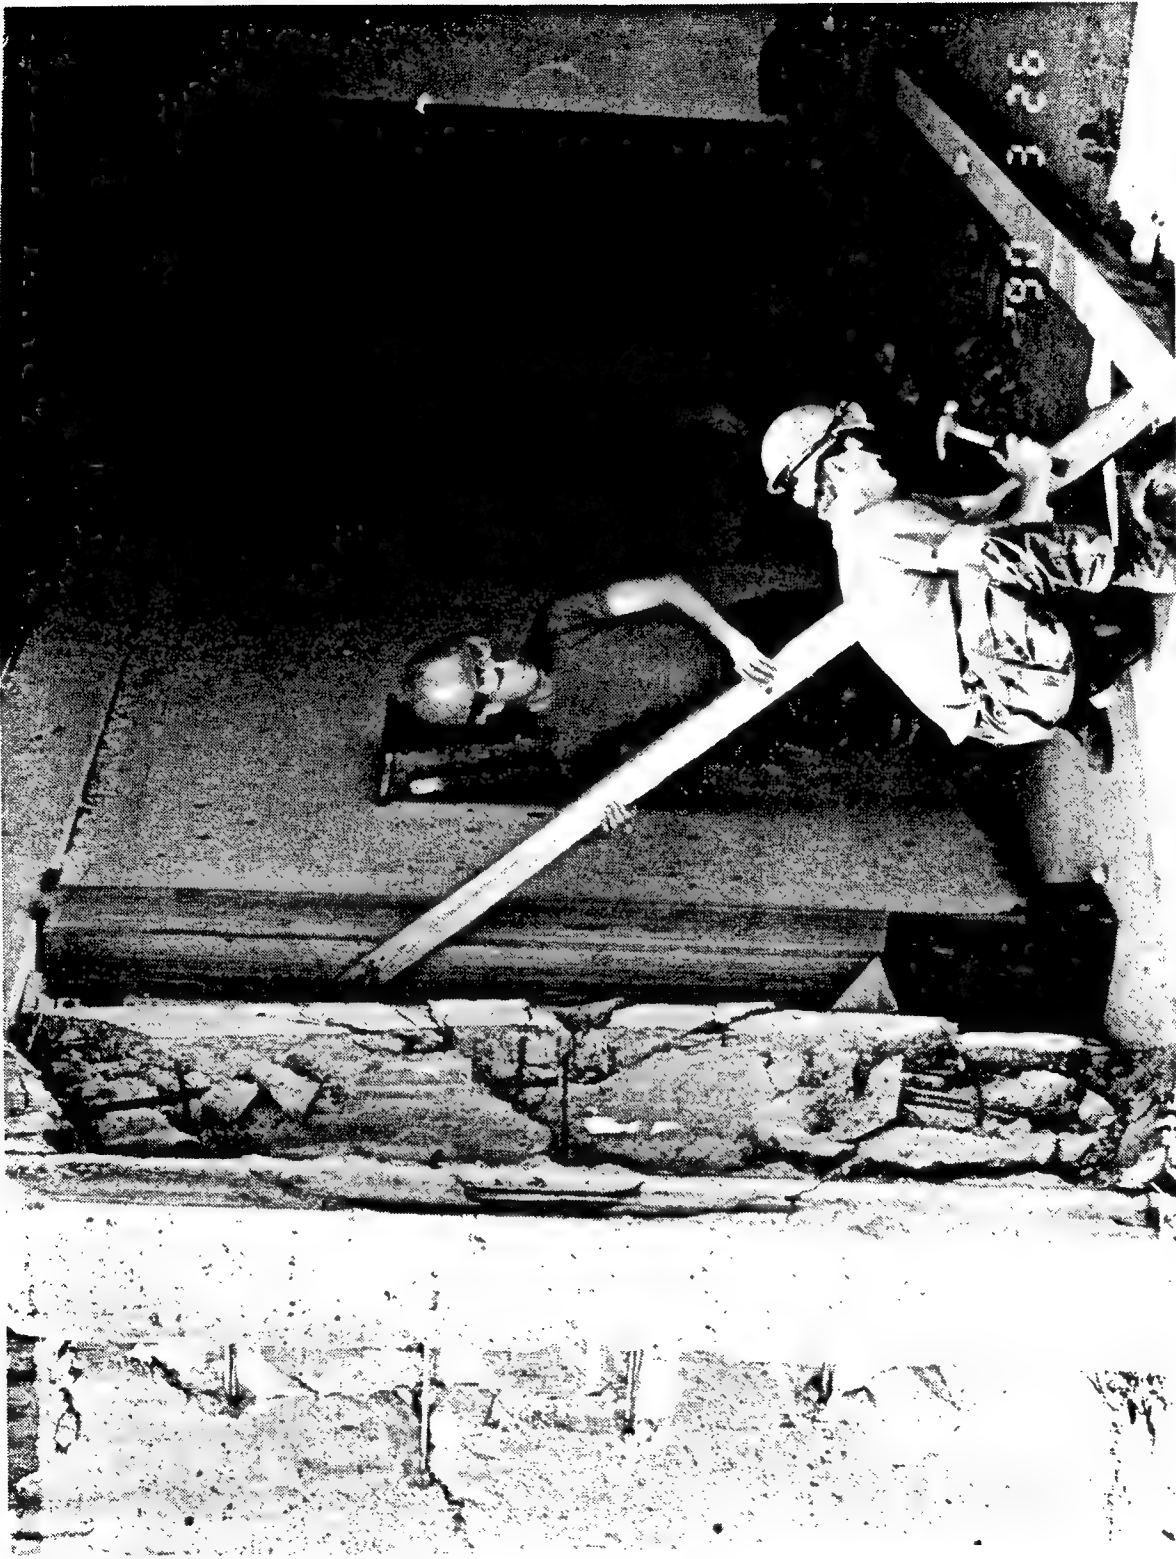
Figure 54. Attaching Lateral Bracing to Replacement Column.

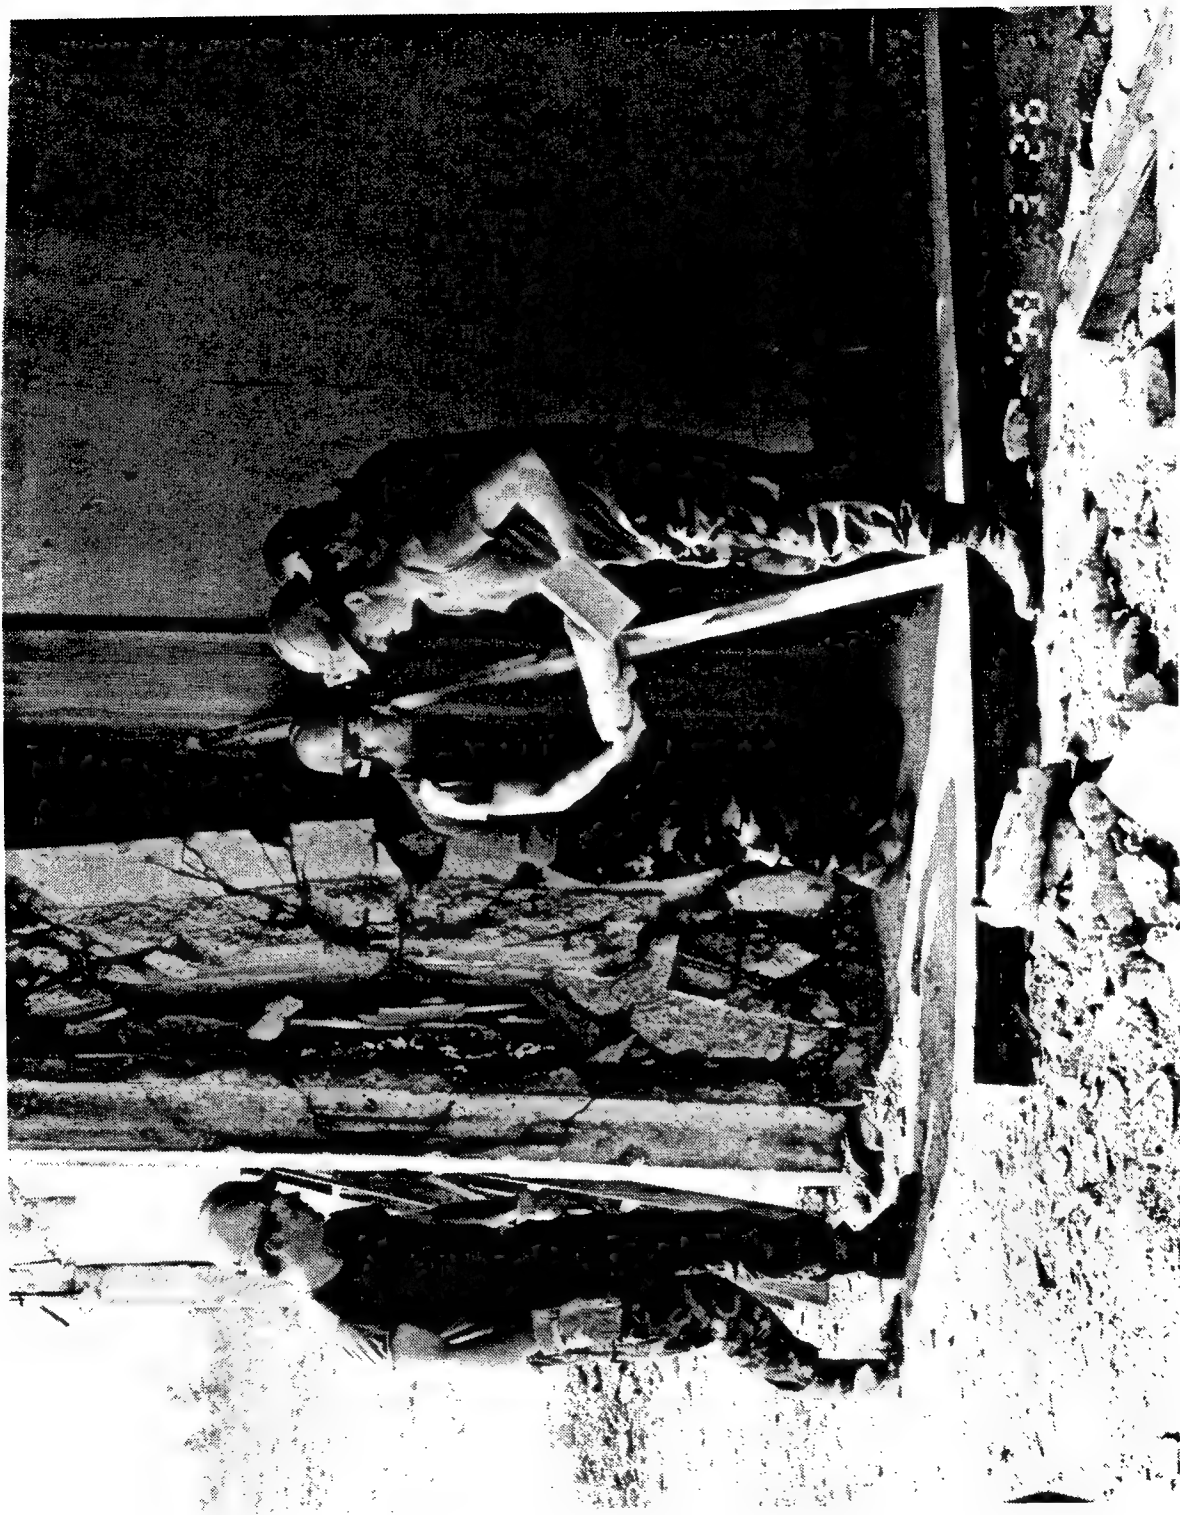
Figure 55. Removing Shoring Jack to Complete the Repair Process.

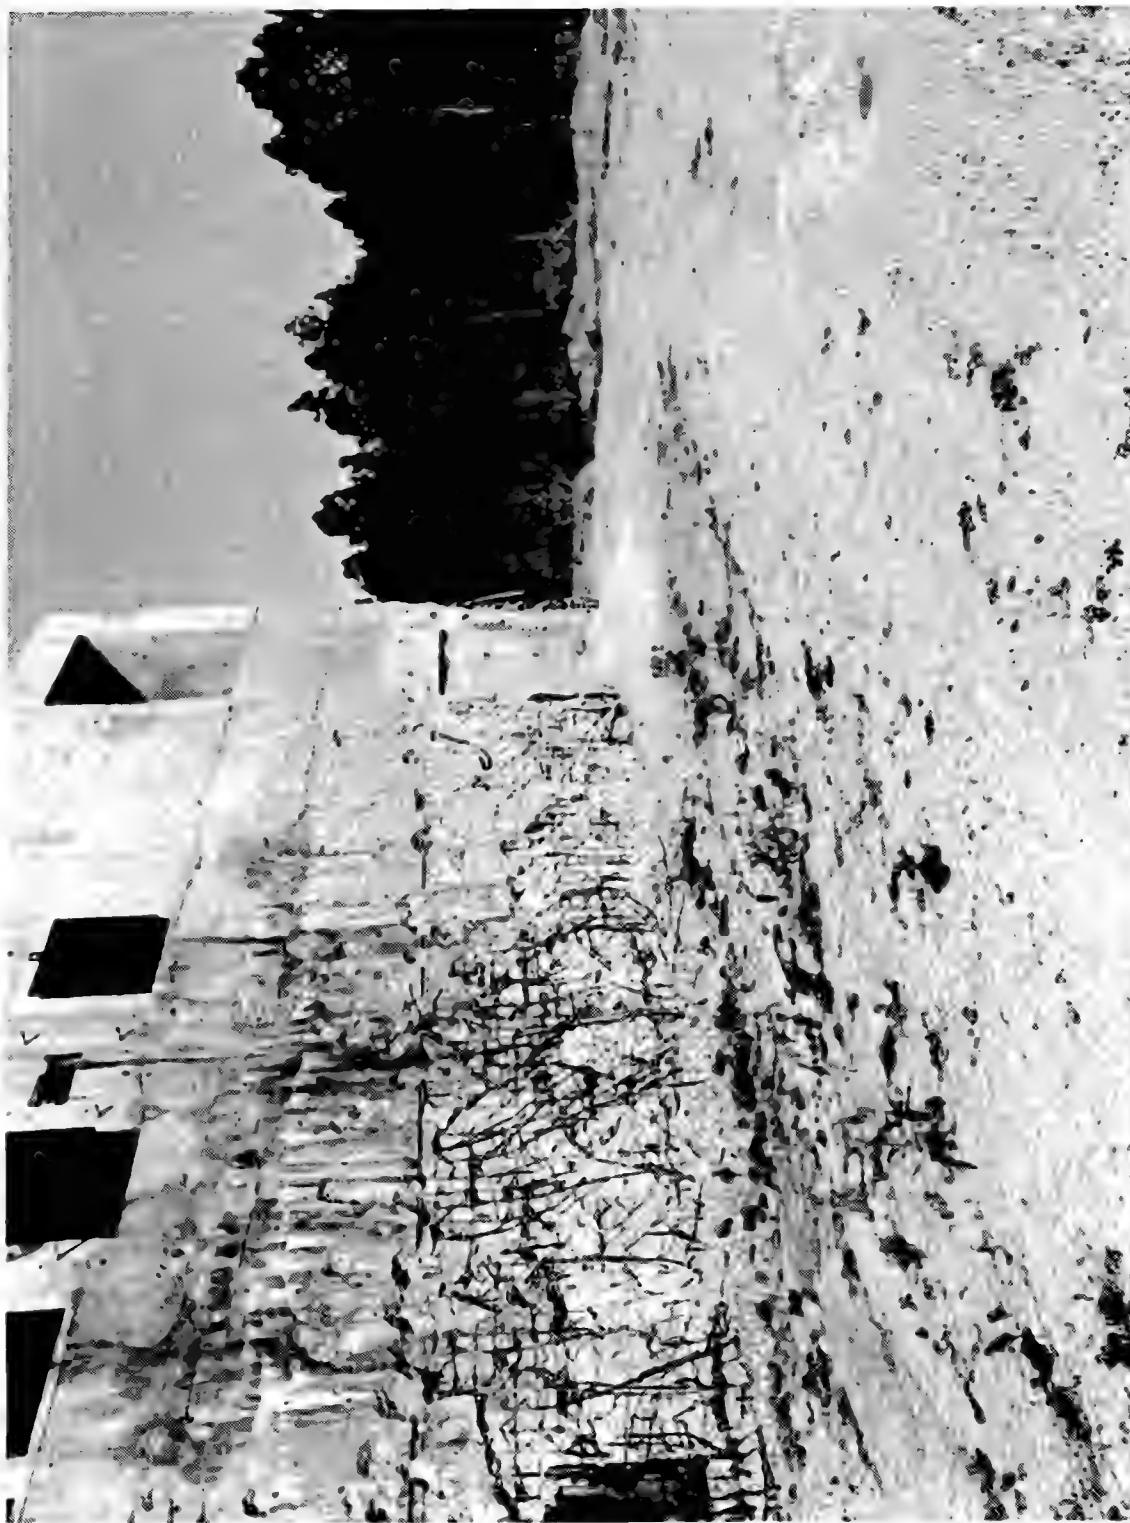
Figure 56. Spall Area of NATO Structure Used for the Wall Breach Repair Field Demonstration.

To simulate a wall breach repair, a spalled area of the NATO structure, shown in Figure 56, was used. This area is located on the northern wall of the structure. A portion of this spalled area approximately 3 feet wide and 4 feet high, was filled in with shotcrete.

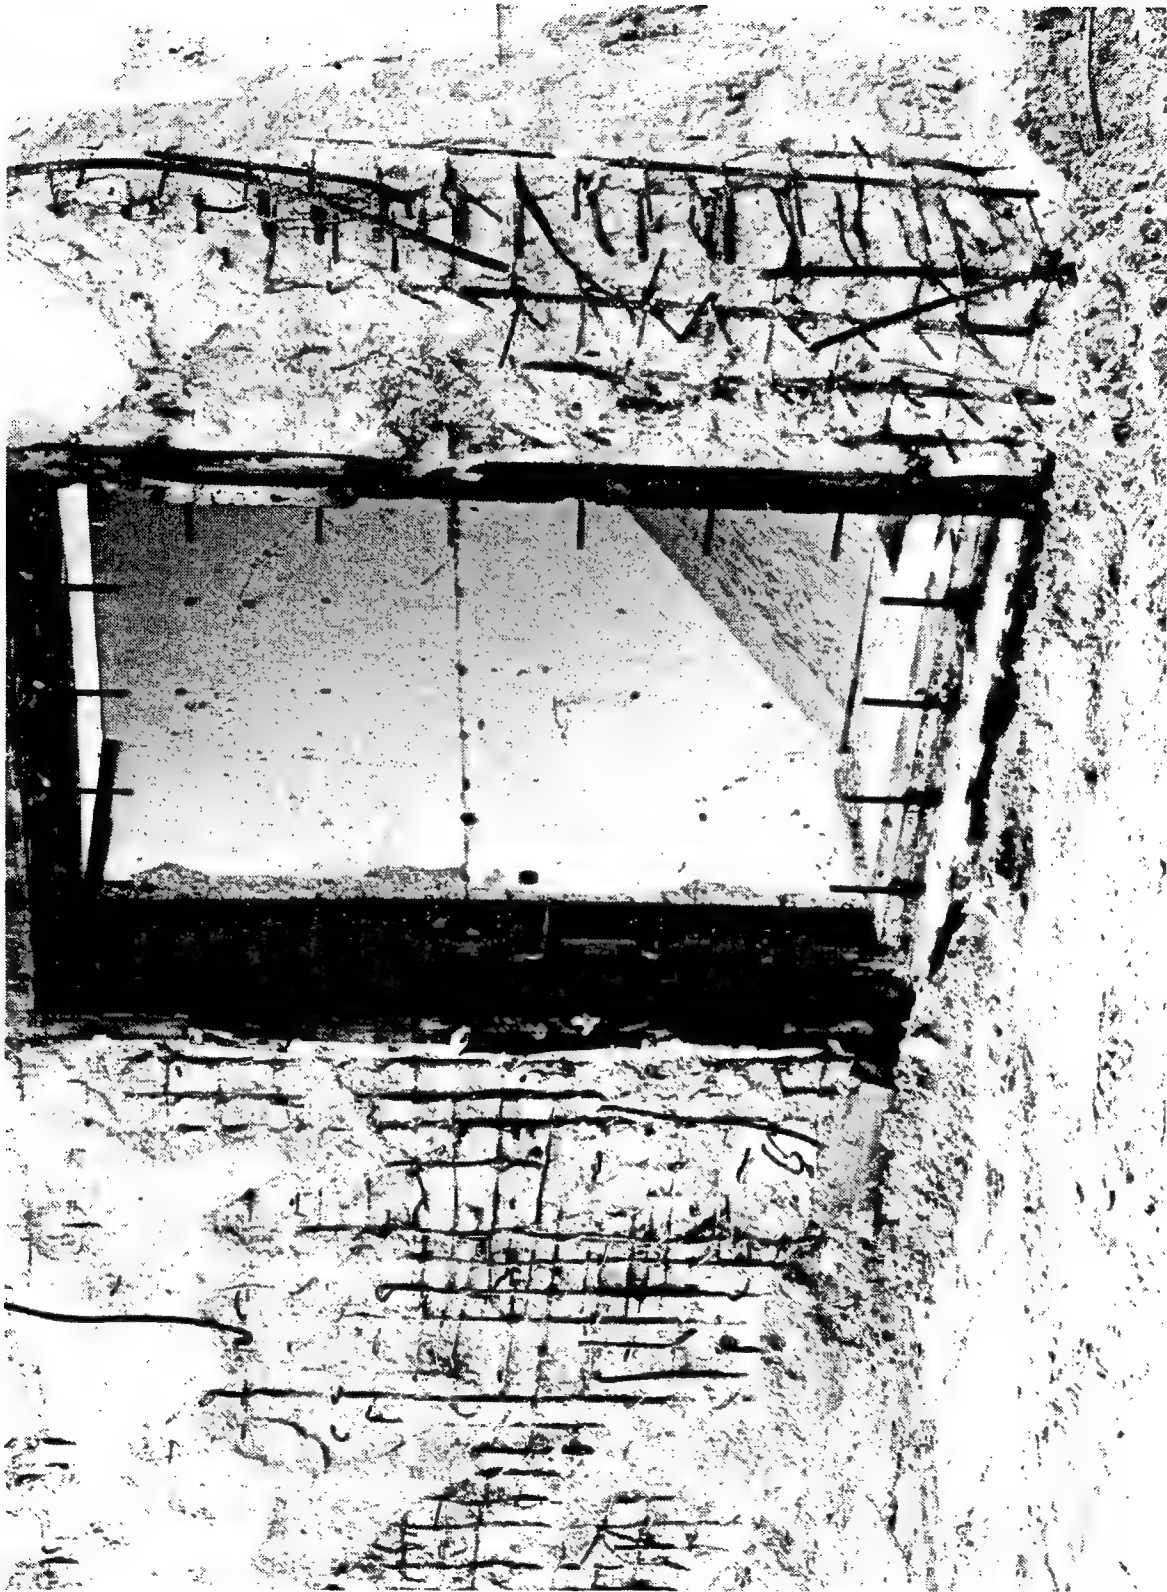
Figure 57. Door Opening in NATO Structure Used for the Wall Replacement Field Demonstration.

To simulate a non-load-bearing wall replacement, a door opening in the NATO structure was used. This door opening, which is shown in Figure 57, is located in the eastern wall of the structure. Prior to the repair, Number 4 rebar stubs were welded along the top, bottom, and sides of the door frame at 1-foot intervals, as shown in Figure 58. The rebar was butt-welded and fillet-welded on both sides for 4 inches. The rebar stubs protruded 6 inches beyond the edge of the door frame. After placing the rebar, a plywood backing was installed in the door opening, as shown in Figures 59 and 60.

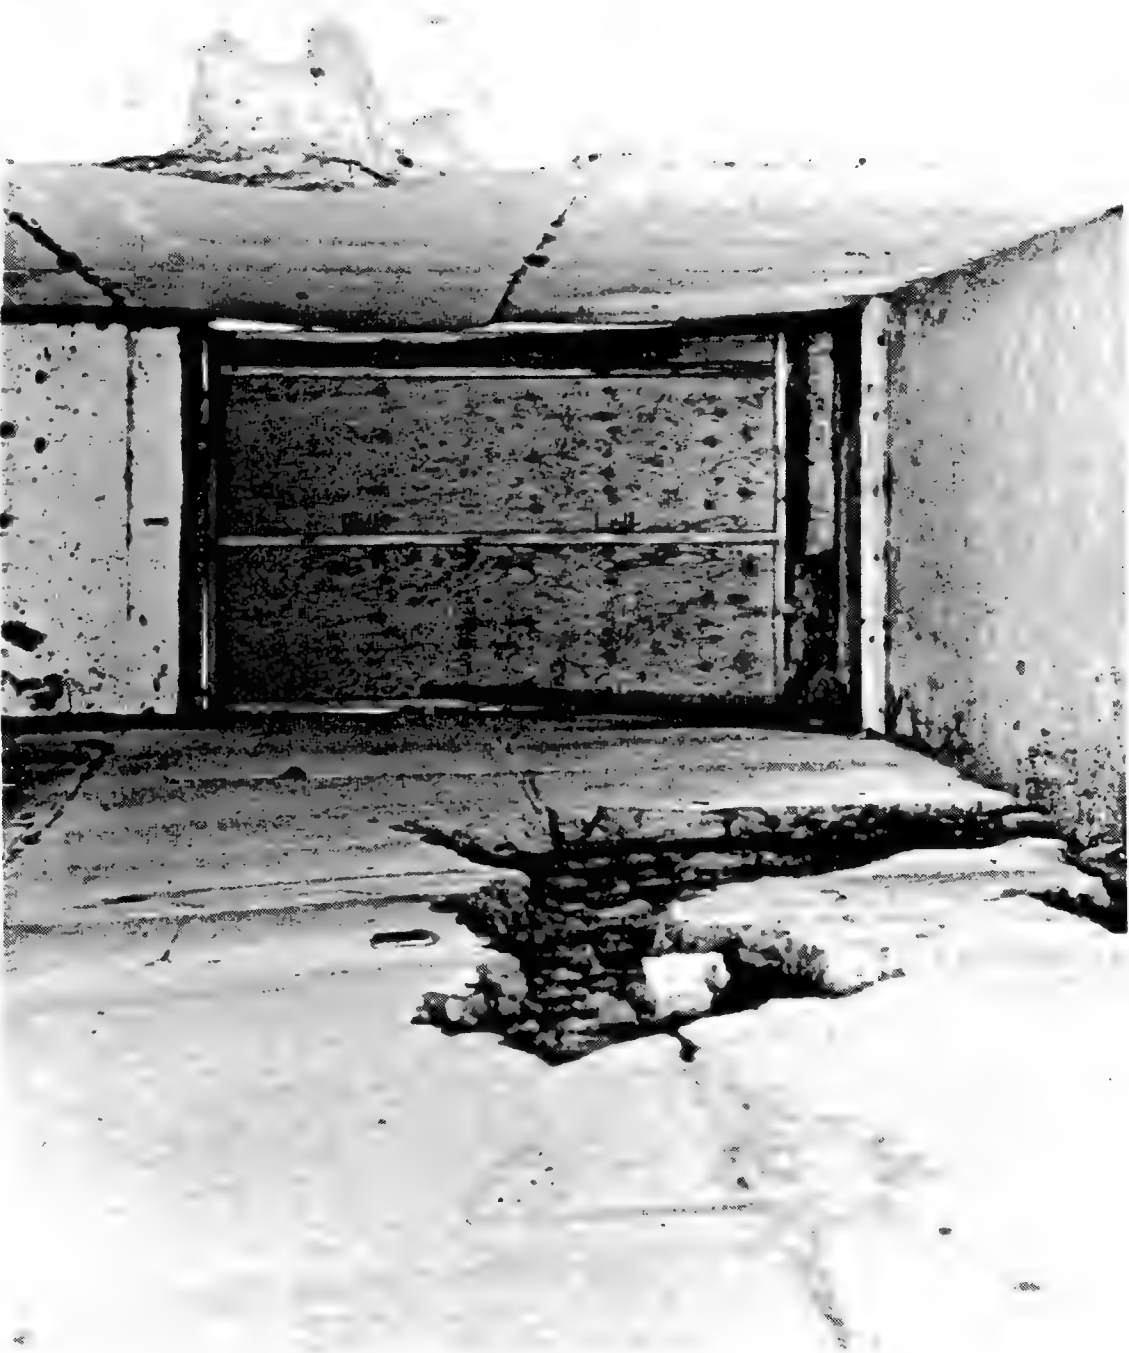
Figure 60. View 2 of Plywood Backing in the Door Opening.

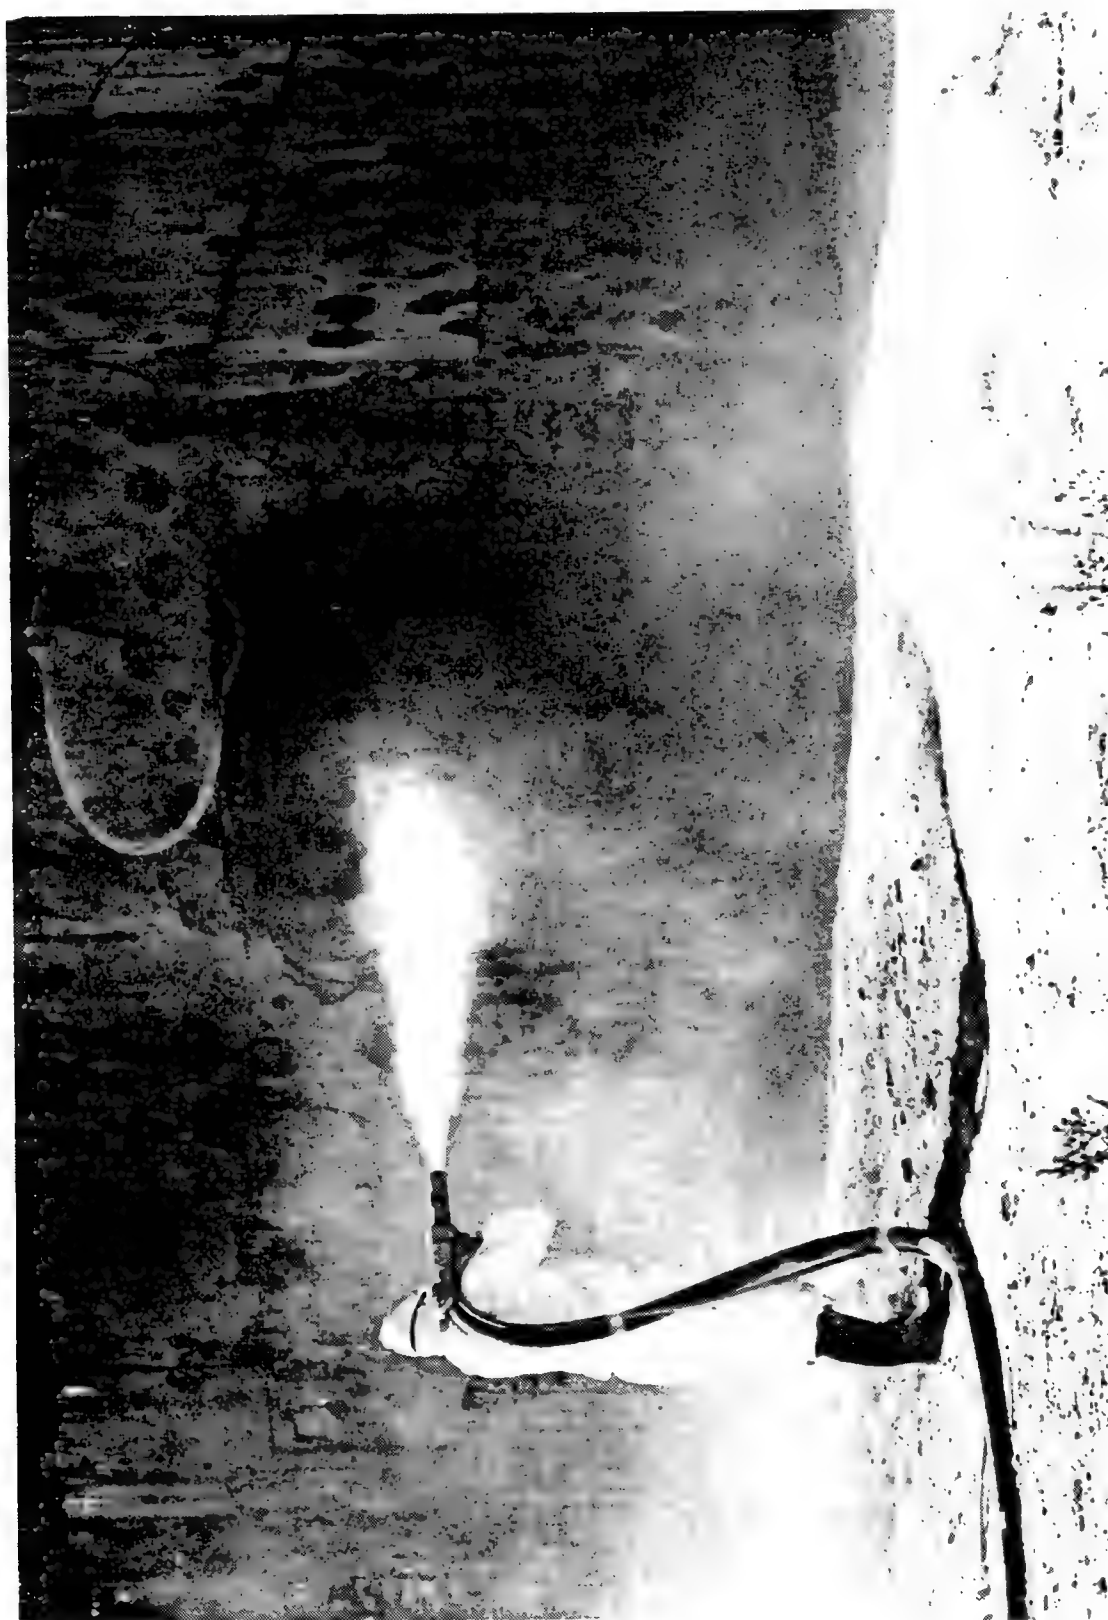
Figure 69. Spraying Shotcrete Material into Repair Area.

Two to four 55-gallon drums of shotcrete material were placed in the concrete bucket, using a specially fabricated drum lift and all-terrain fork-lift, as shown in Figure 66. The crane then positioned the bucket over the shotcrete gun hopper, as shown in Figure 67. In some instances, a wooden funnel was placed in the gun hopper to aid in feeding shotcrete into the hopper. Shotcrete material was fed into the gun hopper by depressing a lever on the concrete bucket as shown in Figure 68. The shotcrete material then fed into a mixing chamber by gravity, from which compressed air propelled it through a hose to the nozzle, where it was mixed with water. The nozzle operator sprayed the shotcrete on the ground until the water/material mixture was acceptable and had stabilized. The nozzle operator then sprayed the mixture onto the repair area as shown in Figure 69.
